# ULSD, Ethanol, Gas, Water and your UST- Do they mix?

Christian Quijano  
Rounds and Associates

John Albert  
Department of Agriculture

Heather Peters  
Department of Natural Resources

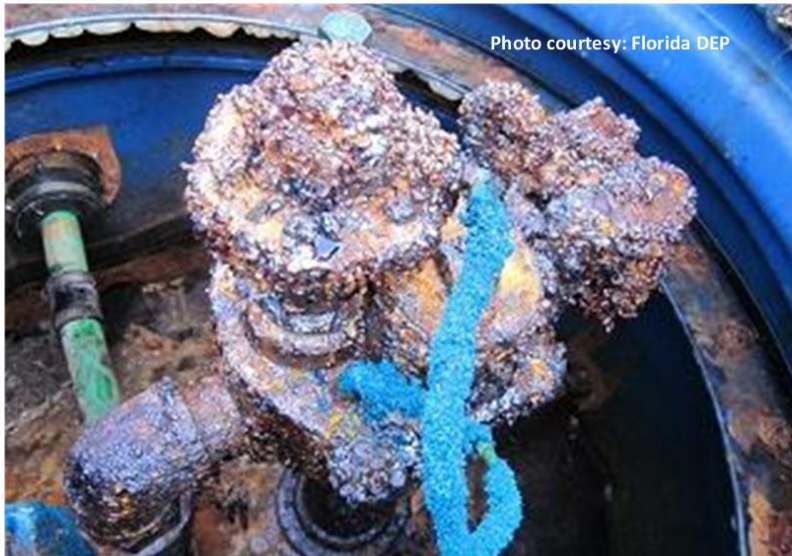
E10 STP, unknown grade (Florida) – Feb. 2011

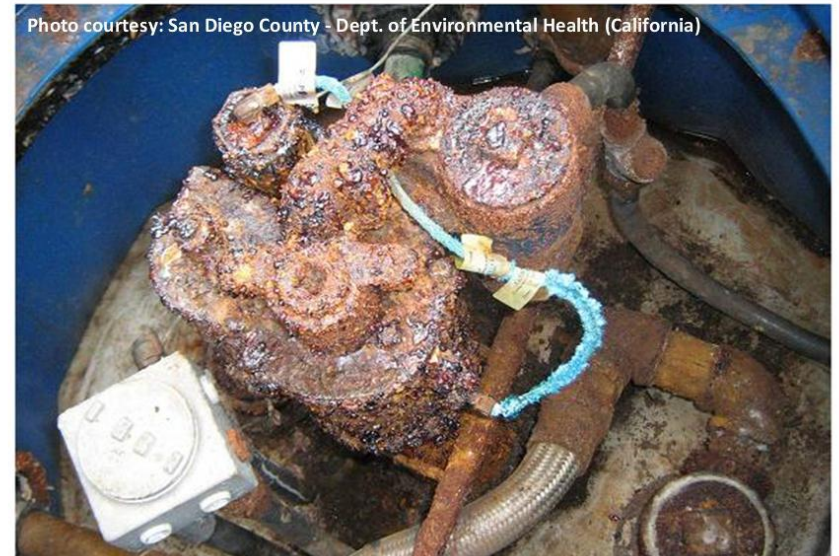
91 octane STP (California) – August 2010

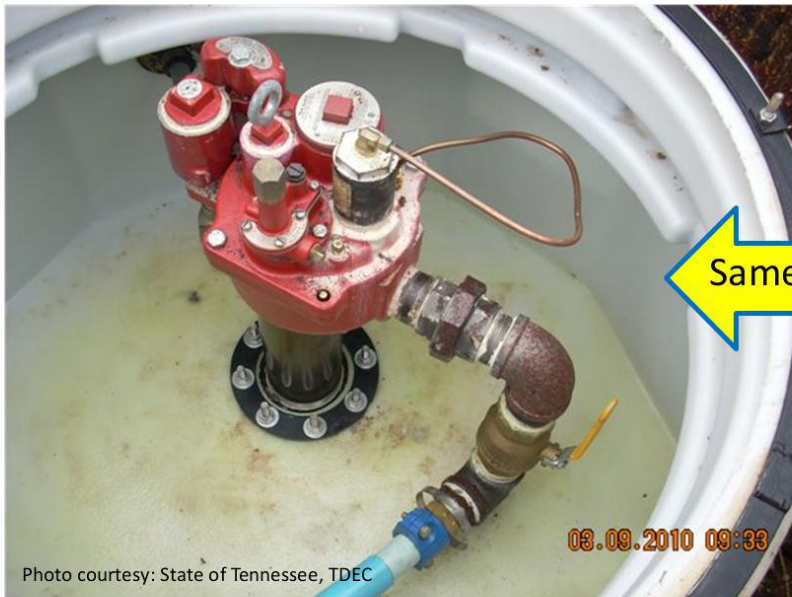
Premium/E10 STP (Tennessee) – March 2010

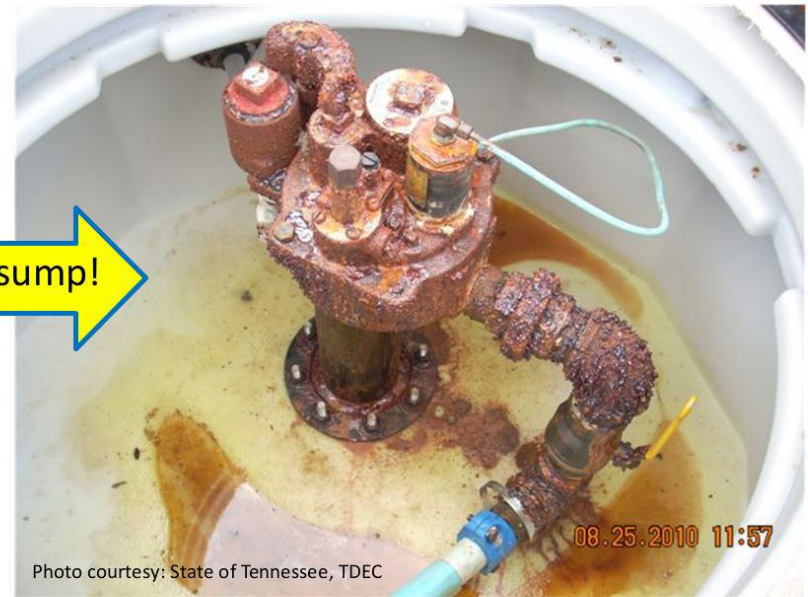
Premium/E10 STP (Tennessee) – August 2010

Same sump!

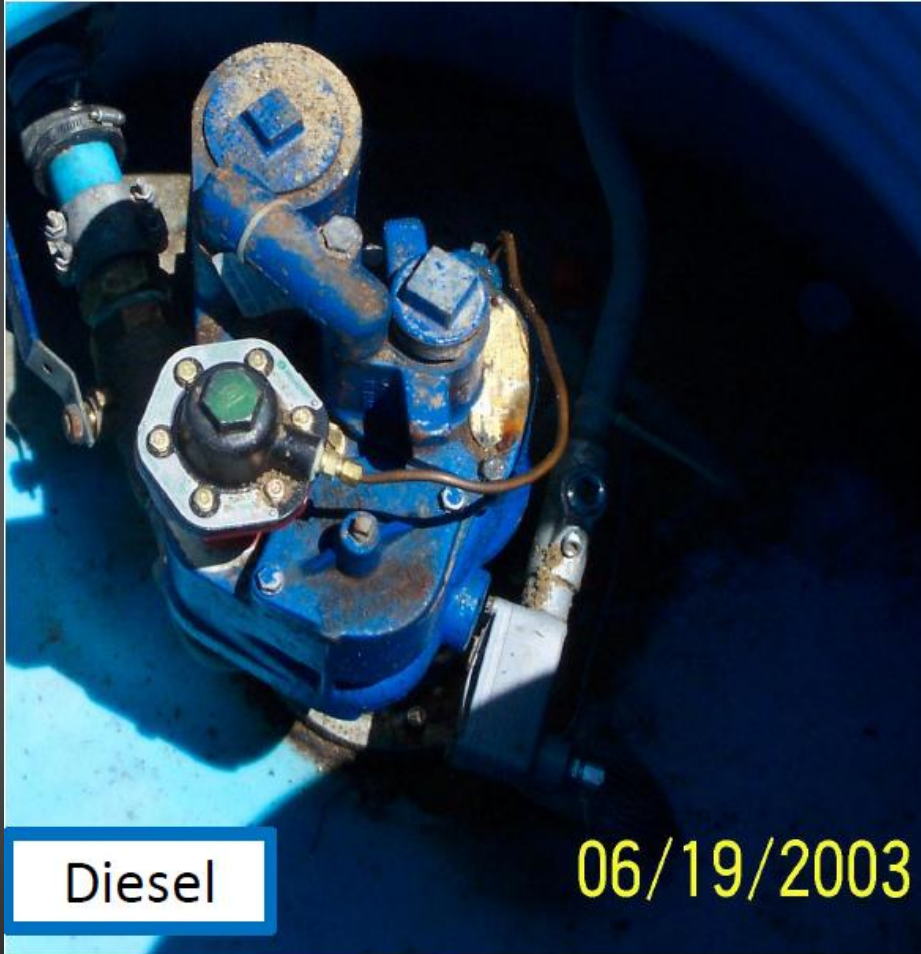
Same Facility - Same Equipment – Same Day- Different Sumps

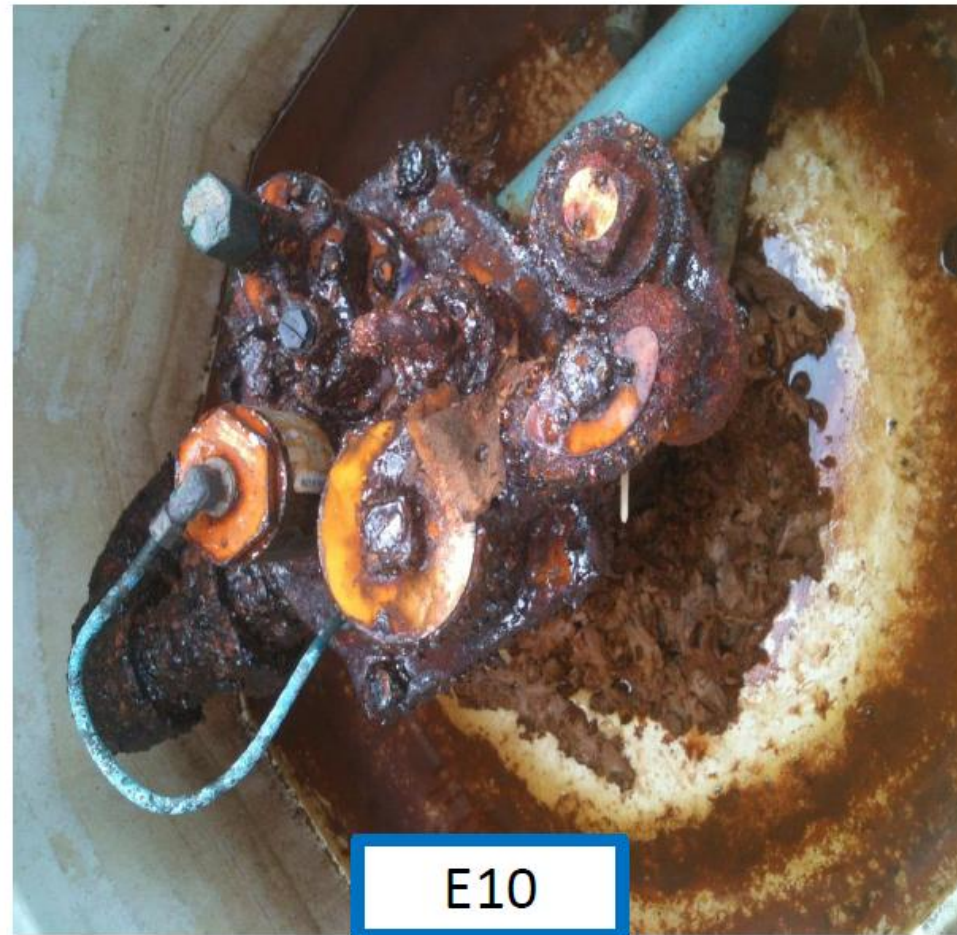
E10

Installed 8-07 - Photos 3-12

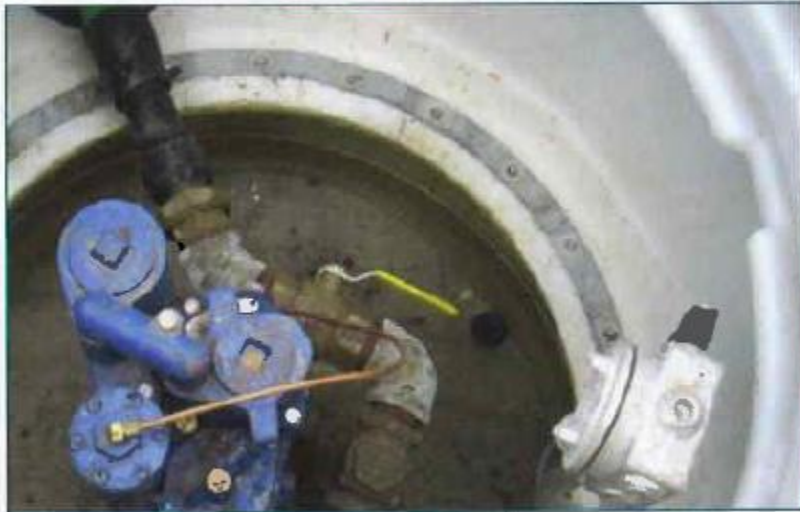
Sump 9, 0.33 mg/L

Comparison of corrosion in sumps with low and high measureable concentrations of acetate in the passive diffusion samplers.

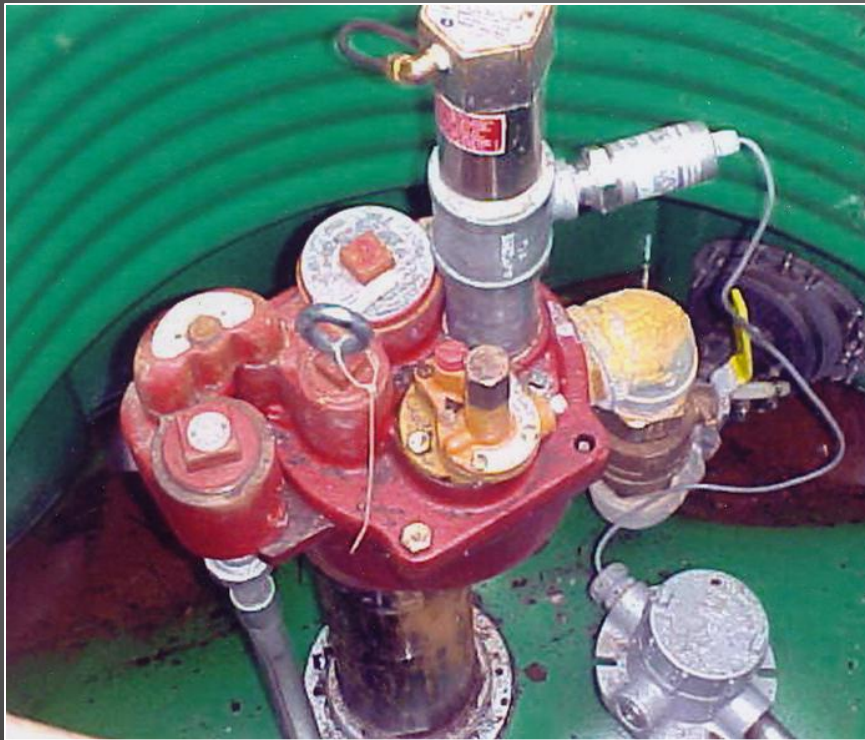
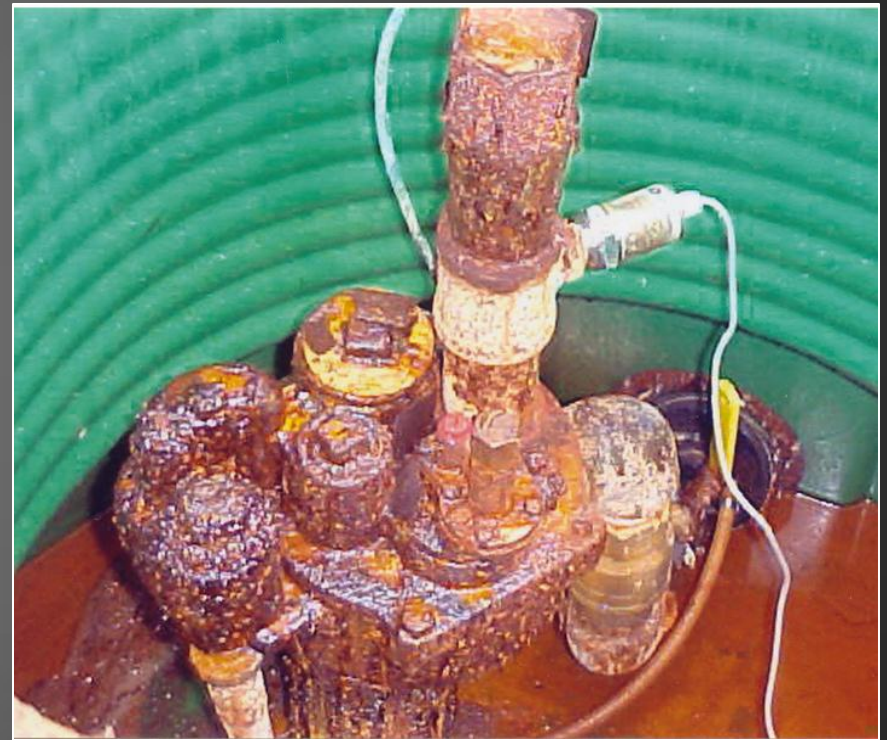
Other examples of corrosion dissimilarity at the same facility.

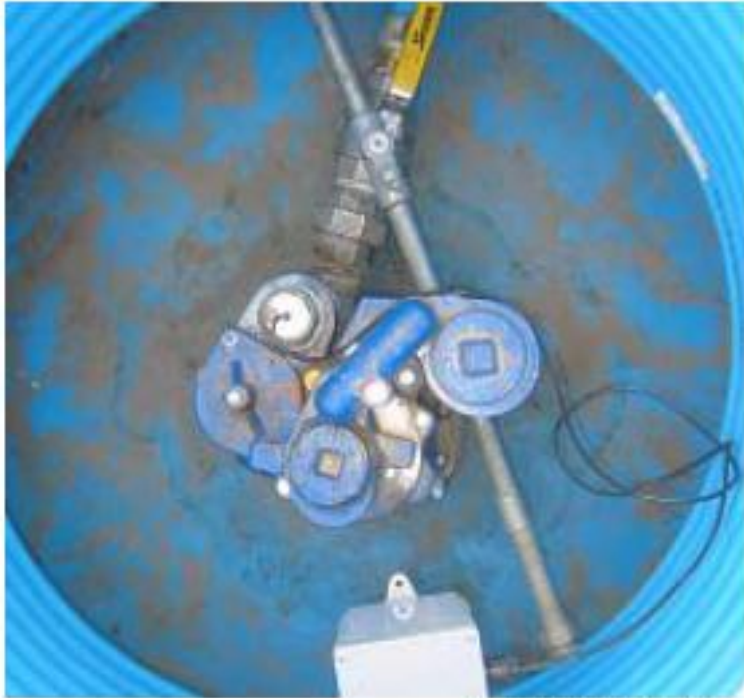
Photo taken 11/3/05

## E-85 Sub after one year of operation (Installed 11/3/05)

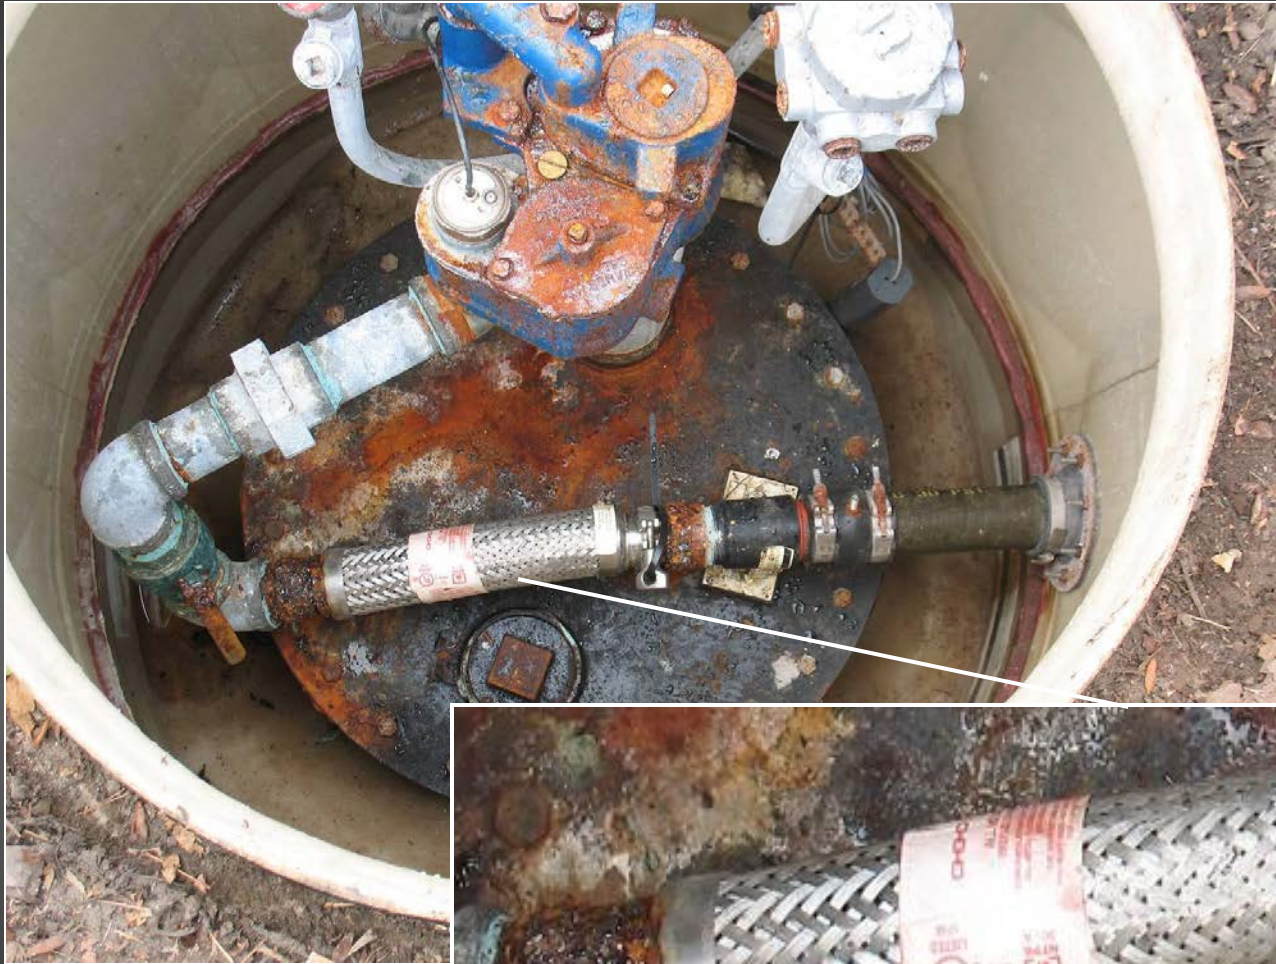
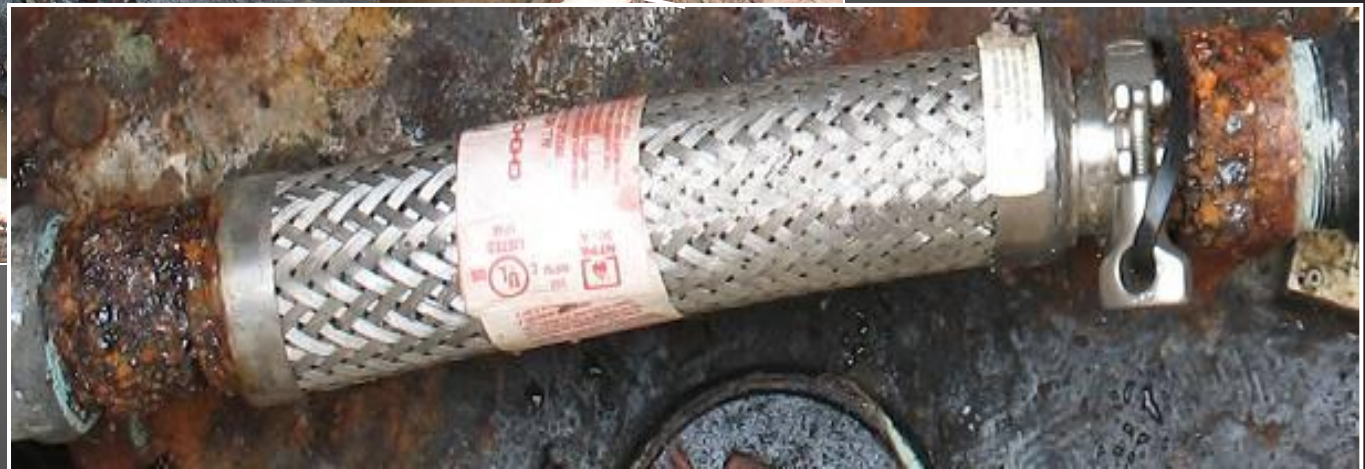
# Corrosion in ethanol STP sump after 2 years of operation!

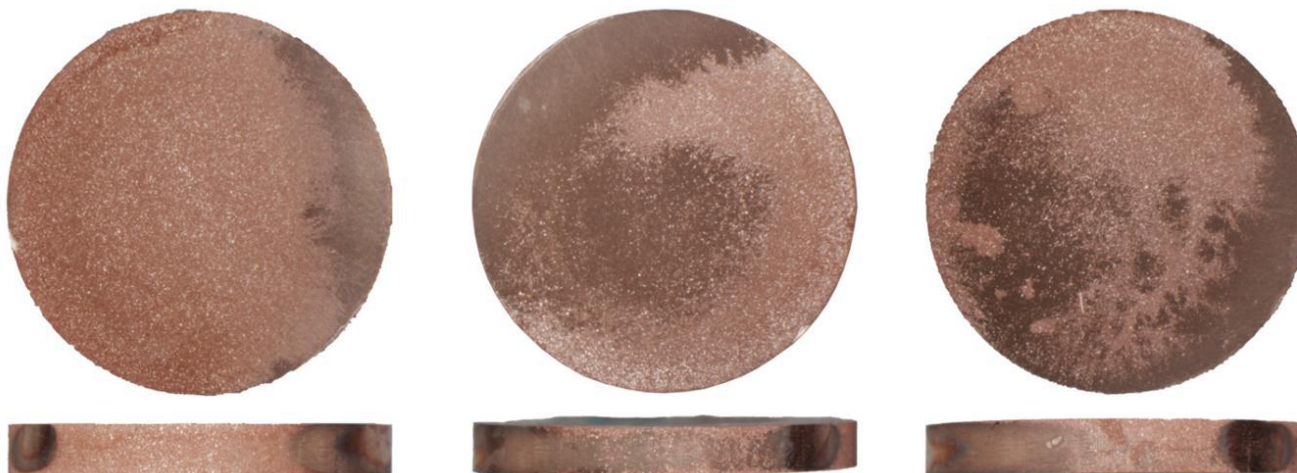
TANK 4

Surface  
Pitting

Corrosion was not as extensive on the immersion coupons as compared to the headspace coupons. Pit morphology exhibited a shallow and coalesced appearance. The test solution notably turned a blue color during testing, indicating the presence of dissolved copper acetate.

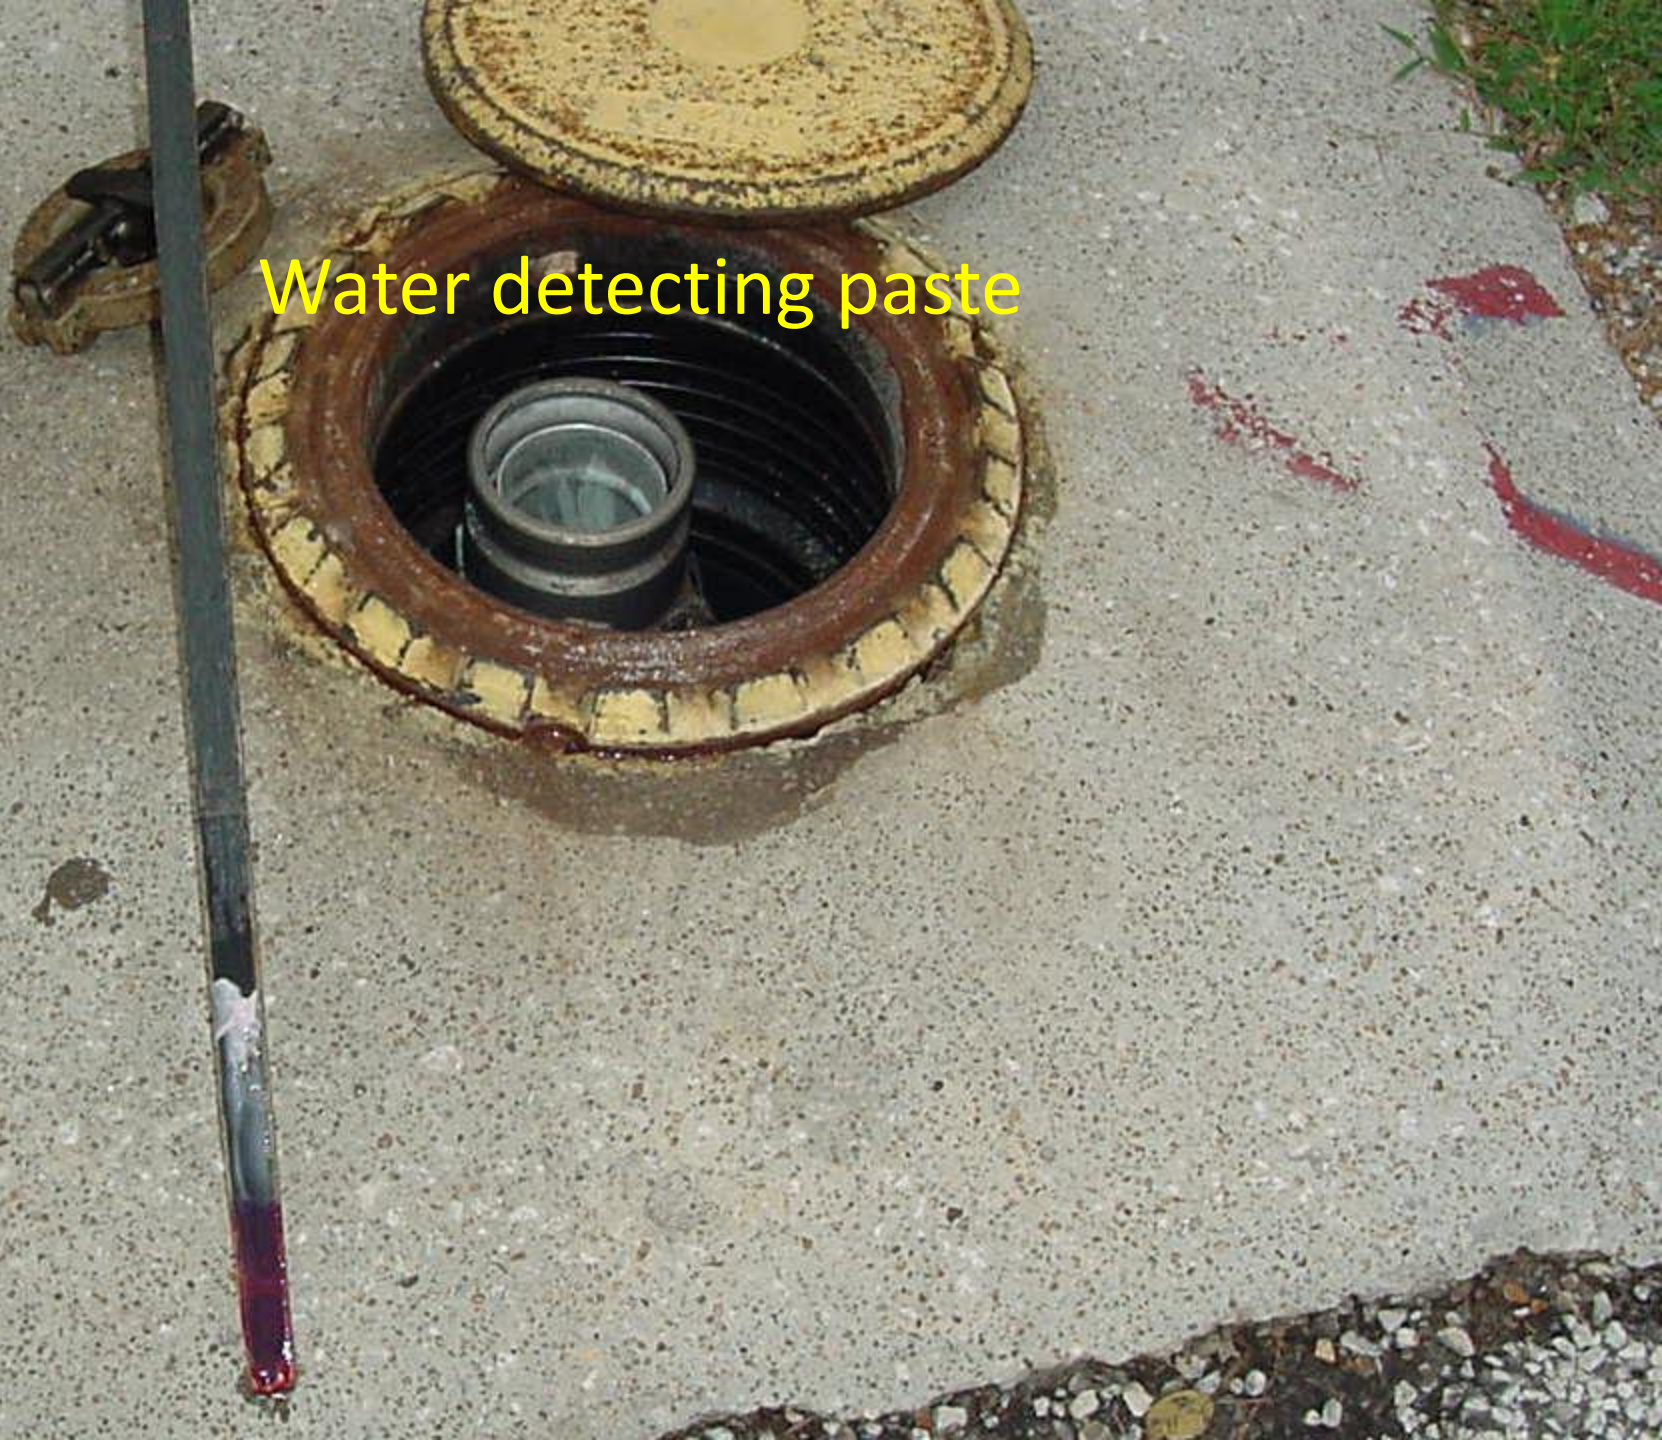
Water detecting paste

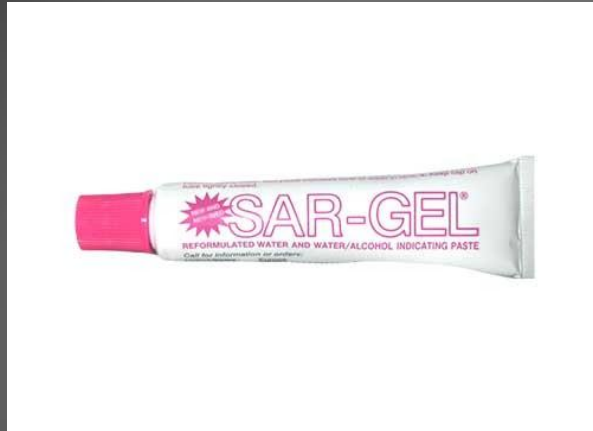
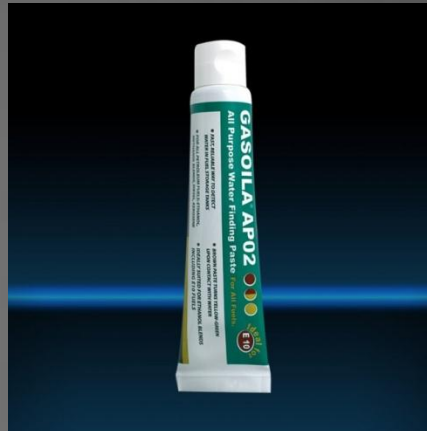
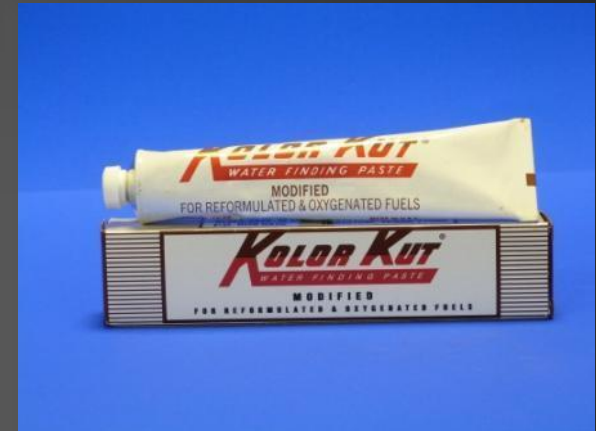
# Examples of Water Finding Paste

- Missouri inspectors use a variety of pastes.
- If found, water is confirmed with a 2<sup>nd</sup> product.
- If results conflict, tank is sampled with tank thief.

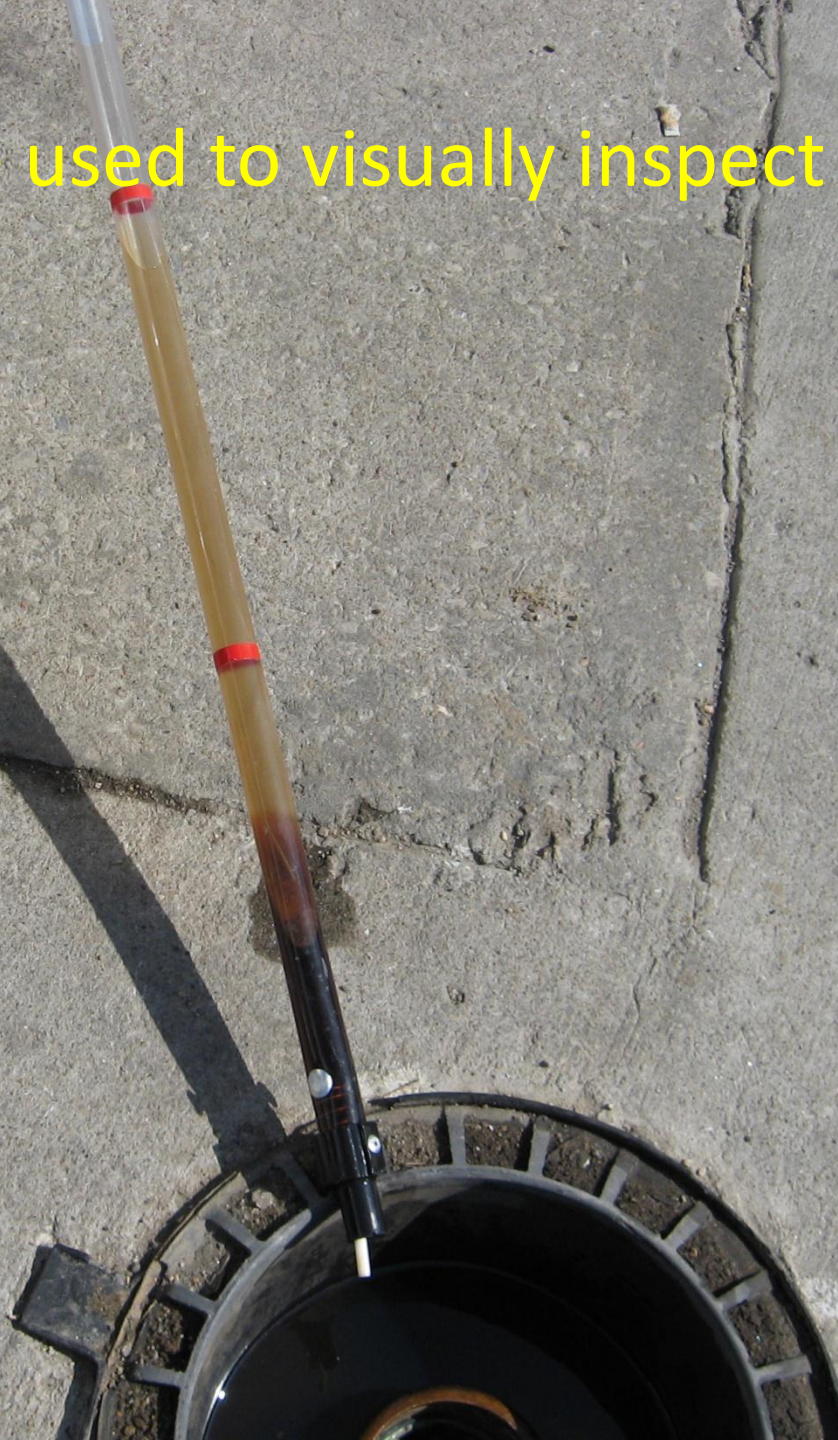
A thief can also be used to visually inspect product

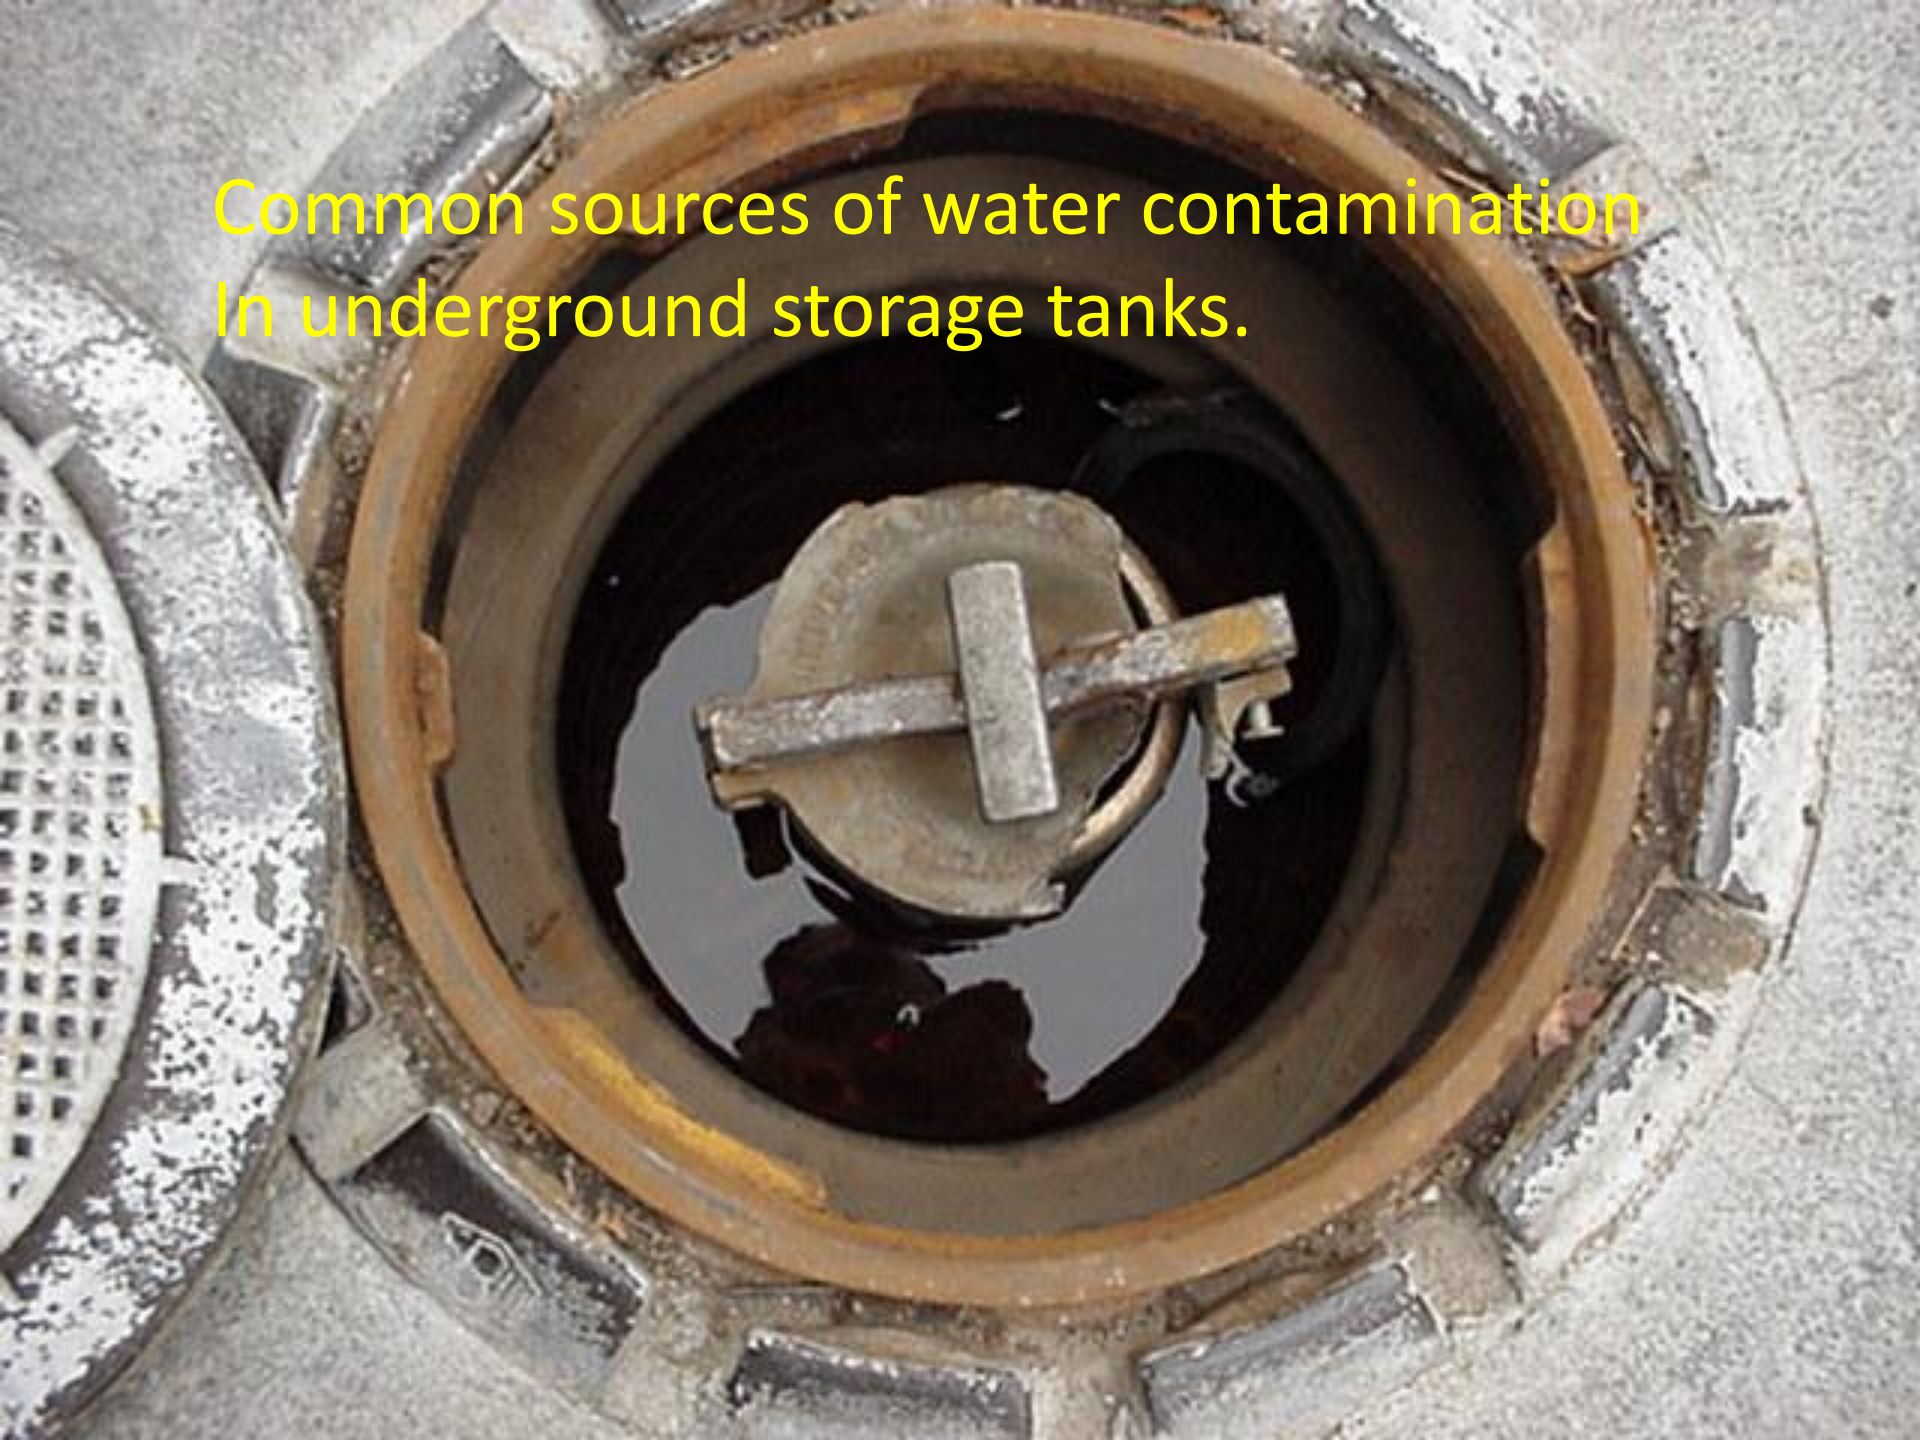
Common sources of water contamination  
In underground storage tanks.

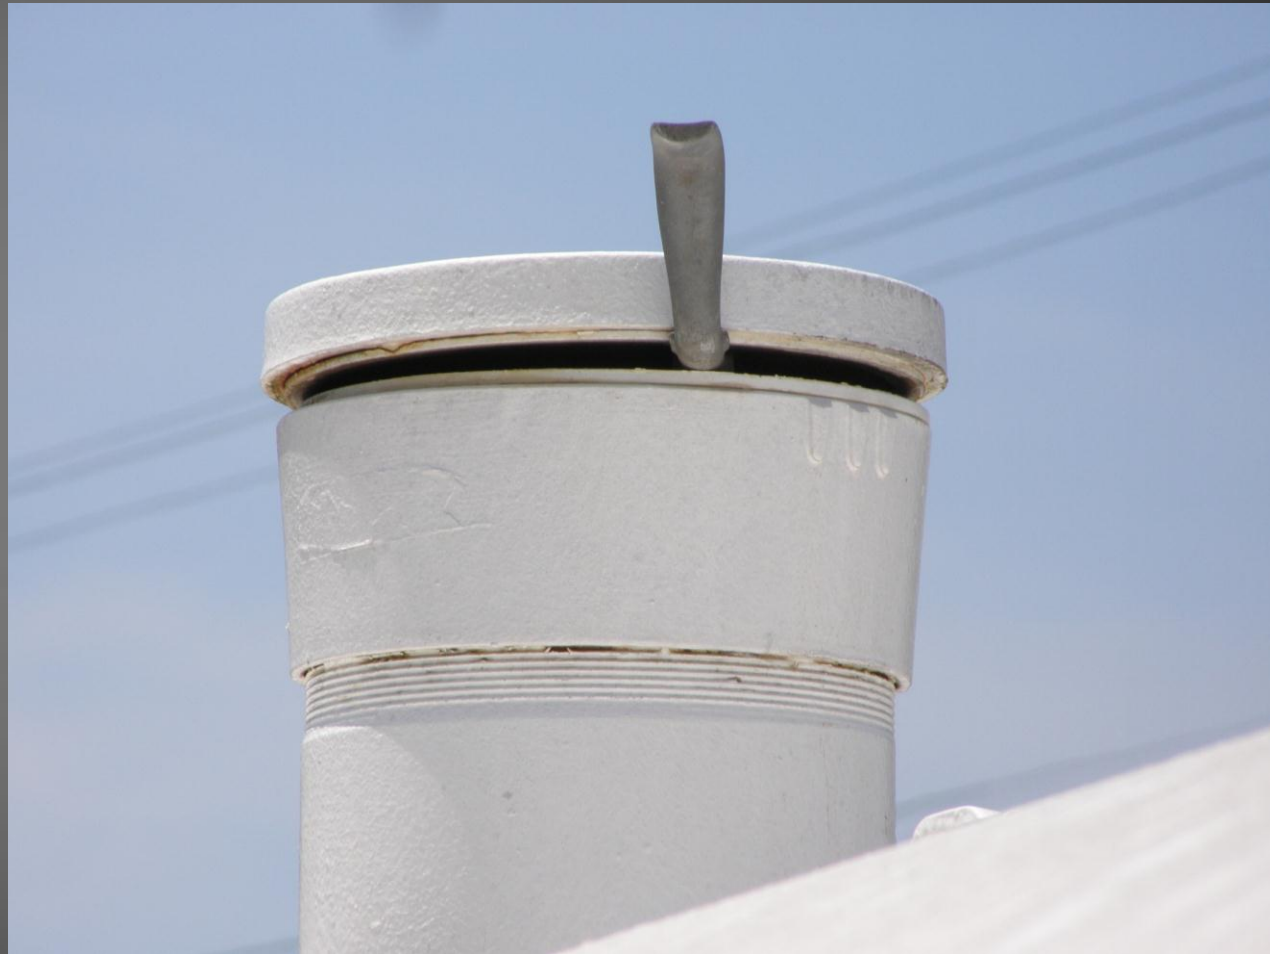
# Common sources of water contamination in aboveground tanks

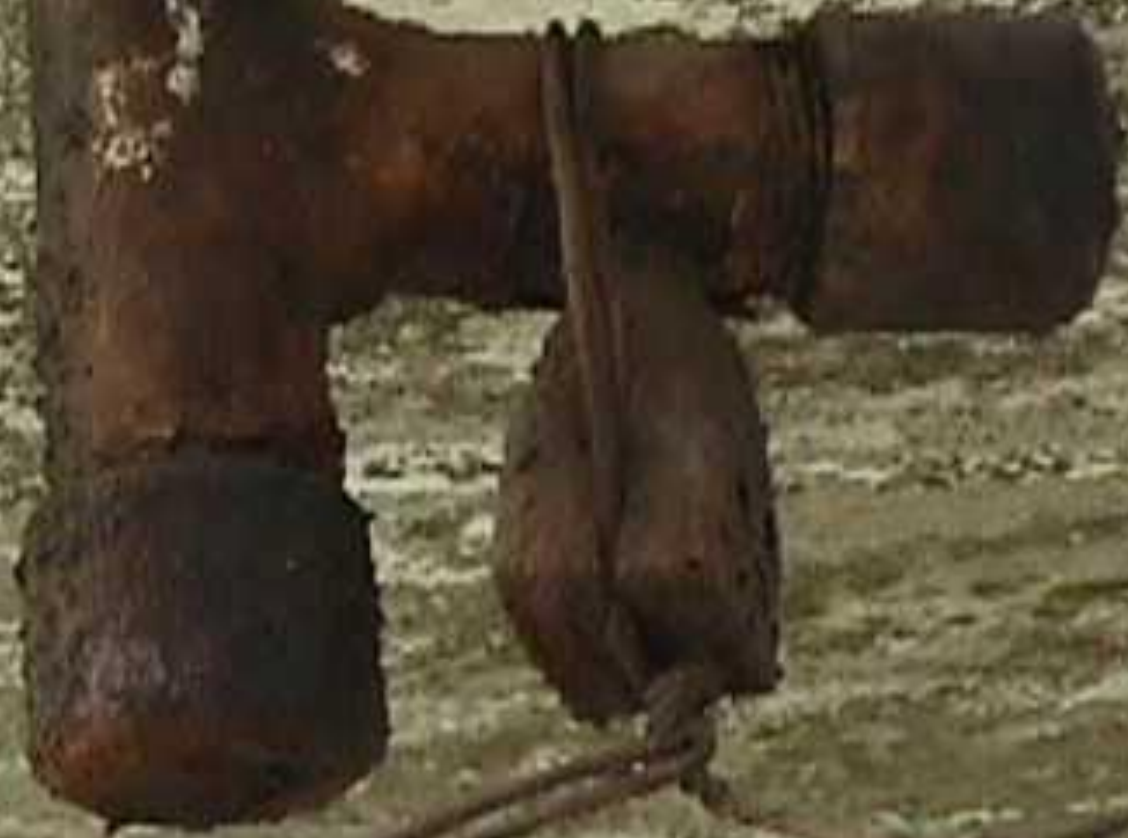
# Methods of water removal for aboveground tanks

- Pumping out water bottoms from the fill openings.
- Difficult to entirely remove all water and especially difficult with vertical aboveground tanks without water draws.
- Water absorbing materials can be a great tool to completely remove water and maintain zero water bottoms.
